# Identifying Double Speed >

Case Study: electric resonance and double speed indication during steam turbine startup

BY JUAN CARLOS ISAMU AND M. THEODORE GRESH

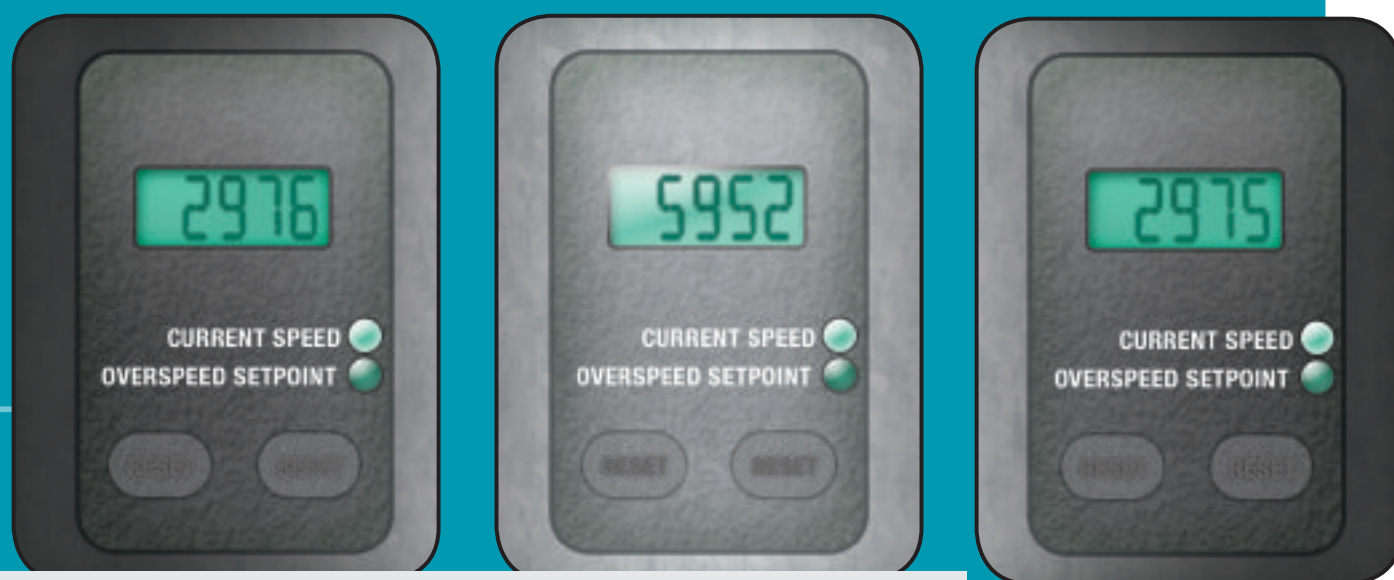
A new steam turbine that was driving a wet gas compressor at a coke plant in São José dos Campos, Brazil, was being commissioned. As the unit got close to 3000 rpm, the speed instruments suddenly doubled their value (without a real speed increment) on the electronic governor — the electronic overspeed and the protection device.

■ Figure 1. One of three speed indicators showing the double speed phenomenon (Middle).

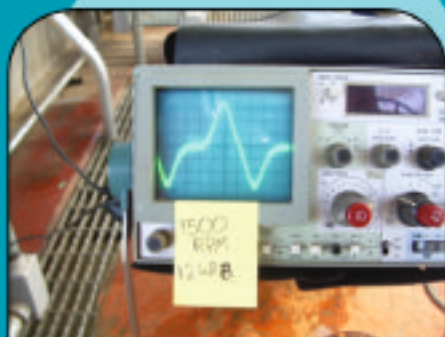
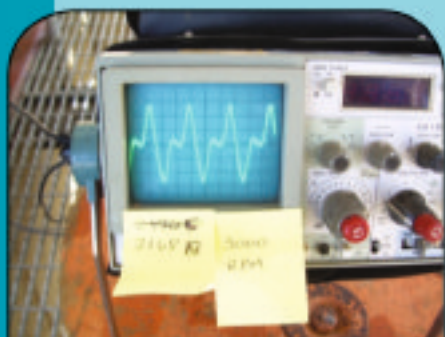
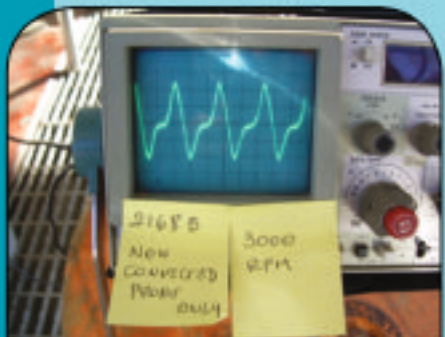
@ 1500 RPM

@ 3000 RPM

@ 3000 RPM  
SENSOR ALONE  
(disconnected)

■ Figure 3. Signal shape.

The basic signal shape when “disconnected” from the governor did not change with the speed; only the amplitude did. The conclusion was that the shape of the signal with the sensor disconnected from the governor depends on the gear tooth shape and speed pickup relative dimension only. Thus, the signal distortion (double peak) was related with the associated electrical circuit. An electronic resonance was the root cause.
